# Manhole Inspection Summary

Manhole # S09GG2005MH

**Location** Address: **6104 IVYMOUNT RD**

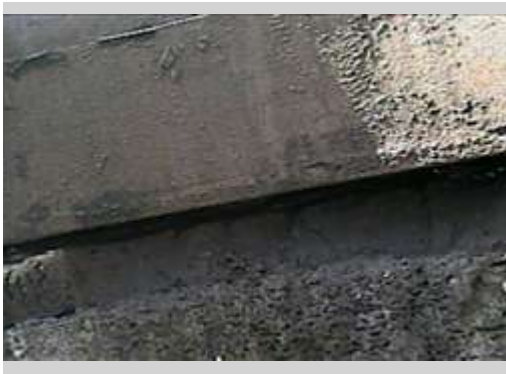
Defect

Infiltration: ☐ None ☒ **Joint** ☐ Cracks ☒ **Mortar** ☐ Roots ☐ Wall

Mineral deposits from frame and adjustment infiltration

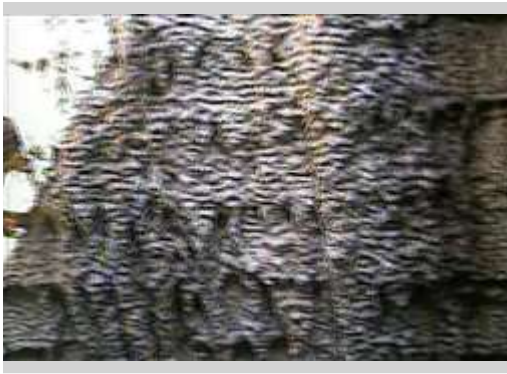
Defect

Comments **Major mineral deposits present in manhole. I4 picture inidcates evidence of infiltration through the mortar of the barrel wall.  
May be close to a rating of a 4 - something to keep an eye on in the future.**

Mineral deposits

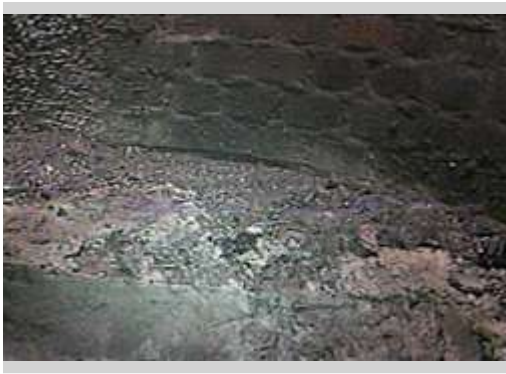
Defect

Condition: ☐ Sound ☐ Cracked ☐ Root Intrusion ☐ Deteriorated ☐ Leaks ☒ **Debris**

Bench debris

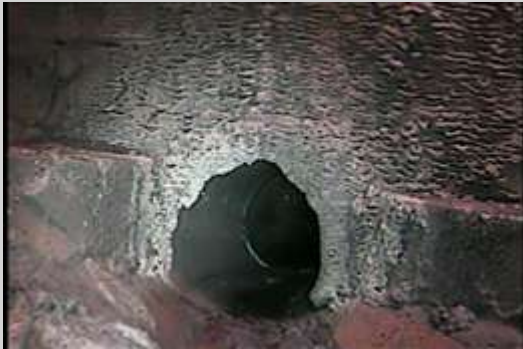
### 8 in. Circular Gravity Sewer Pipe Out @ 12 O'Clock

mineral deposits around outlet

Infiltration: **Evidence** Pipe Seal Cond: **Unknown**
